INVESTIGATIVE REPORT MARVIN FIRE

NOVEMBER 12, 2005

VIRGINIA DEPARTMENT OF FORESTRY

INVESTIGATIVE REPORT

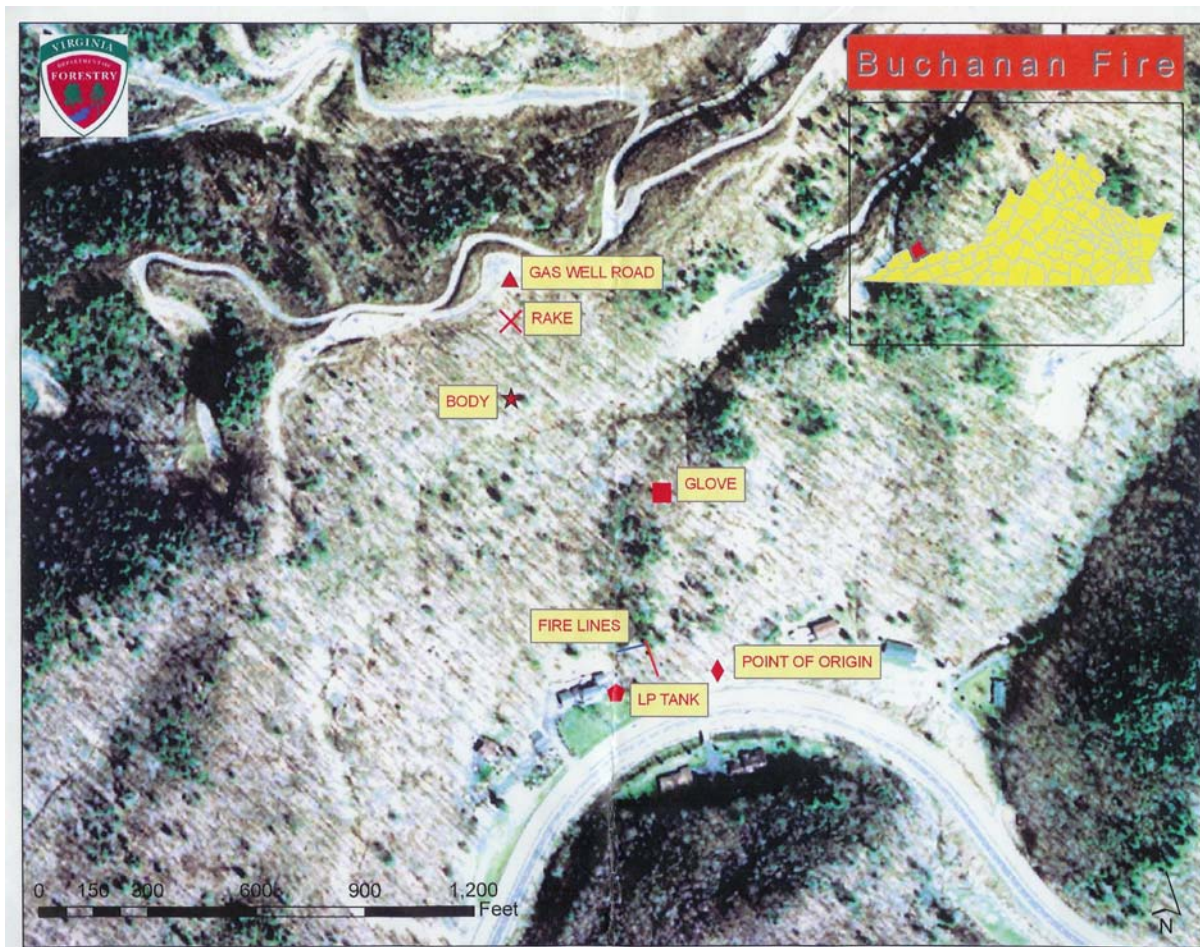
Figure 1

On Saturday, November 12, 2005, a wildland fire occurred on private land near the small community of Marvin, Virginia. According to witnesses, the fire began between approximately 1100 and 1200, the result of a riding lawnmower catching fire at a private residence along Highway 460. The fire began near the residence of the landowner and spread rapidly uphill onto steep terrain. In addition, several other private homes and associated capital facilities were threatened. Several local volunteer fire departments responded initially to the fire, including the Oakwood Volunteer Fire Department. The Chief of the department, Max Willard, was among the first responders to arrive on the scene. According to testimony given to investigators, Chief Willard deployed fire department resources in initial attack activities protecting homes near the origin of the fire. In the interim, Chief Willard scouted upslope, apparently on his own with no communications, with the intent to size-up fire activity and gather information about what could be done tactically to bring the fire under control. Chief Willard was not heard from or seen again until his body was found on Sunday morning, November 13th. The circumstances surrounding his death are unknown. However, the location and physical condition of the body suggests that he was involved in fire suppression activity near the head of the fire on the steep slopes located above the initial ignition point (figure 1).

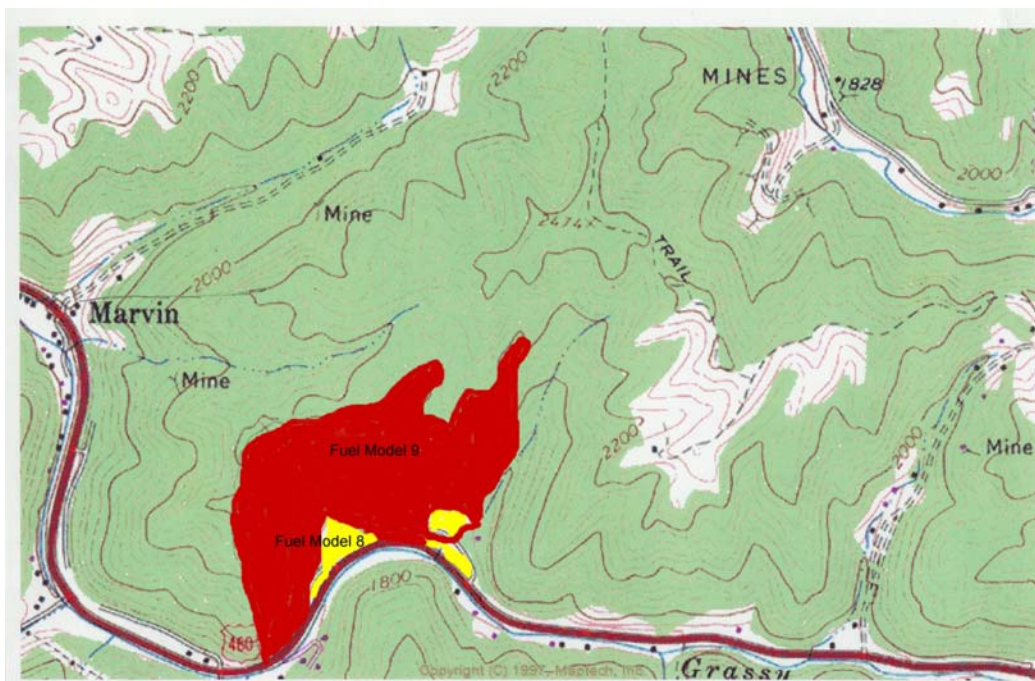
Figure 2

Fuels in the fire area are relatively homogeneous and are classified as hardwood leaf litter, NFFL fuel models 8 and 9. The attached fuel model map (figure 2) shows the locations of fuel models 9 and 8. For both fuel models, fuel loading was found to be relatively light (<12 tons/acre for FM 9 and <7 tons/acre for FM 8). The primary fuel found was hardwood leaf litter (1-hr timelag fuel). The presence of 10-hr (1/4 – 1 in diameter), 100-hr (1-3 in diameter), and 1000-hr (3 in>) fuels was far less than expected. Although some brush fuels (rhododendron and mountain laurel) were present, their impact on fire behavior was negligible due to the scarcity of fuel loading in these fuel types. Due to the drought conditions in evidence at the time of the fire, these fuels would normally have been expected to exert a significant influence upon fire behavior, since live fuel moistures in these species were very low.

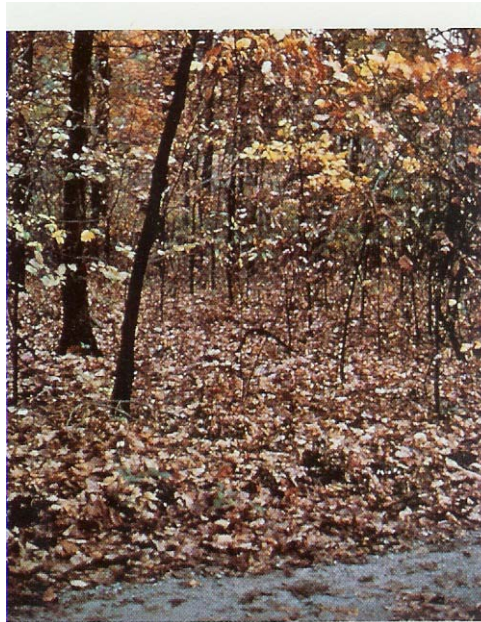
Figure 3

The majority of the fire area is populated by species that contribute significantly to fire behavior as represented by NFFL fuel model 9 (figure 3). Particularly on upper slopes, quantities of chestnut oak, hickory, red oak, and

mixed hardwood species provide ample quantities of fine fuel in the form of hardwood leaf litter, the primary carrier of fire in this assessment. At the time of the fire, these leaves were very dry and “fluffy”, having recently fallen from the overhead tree canopy.

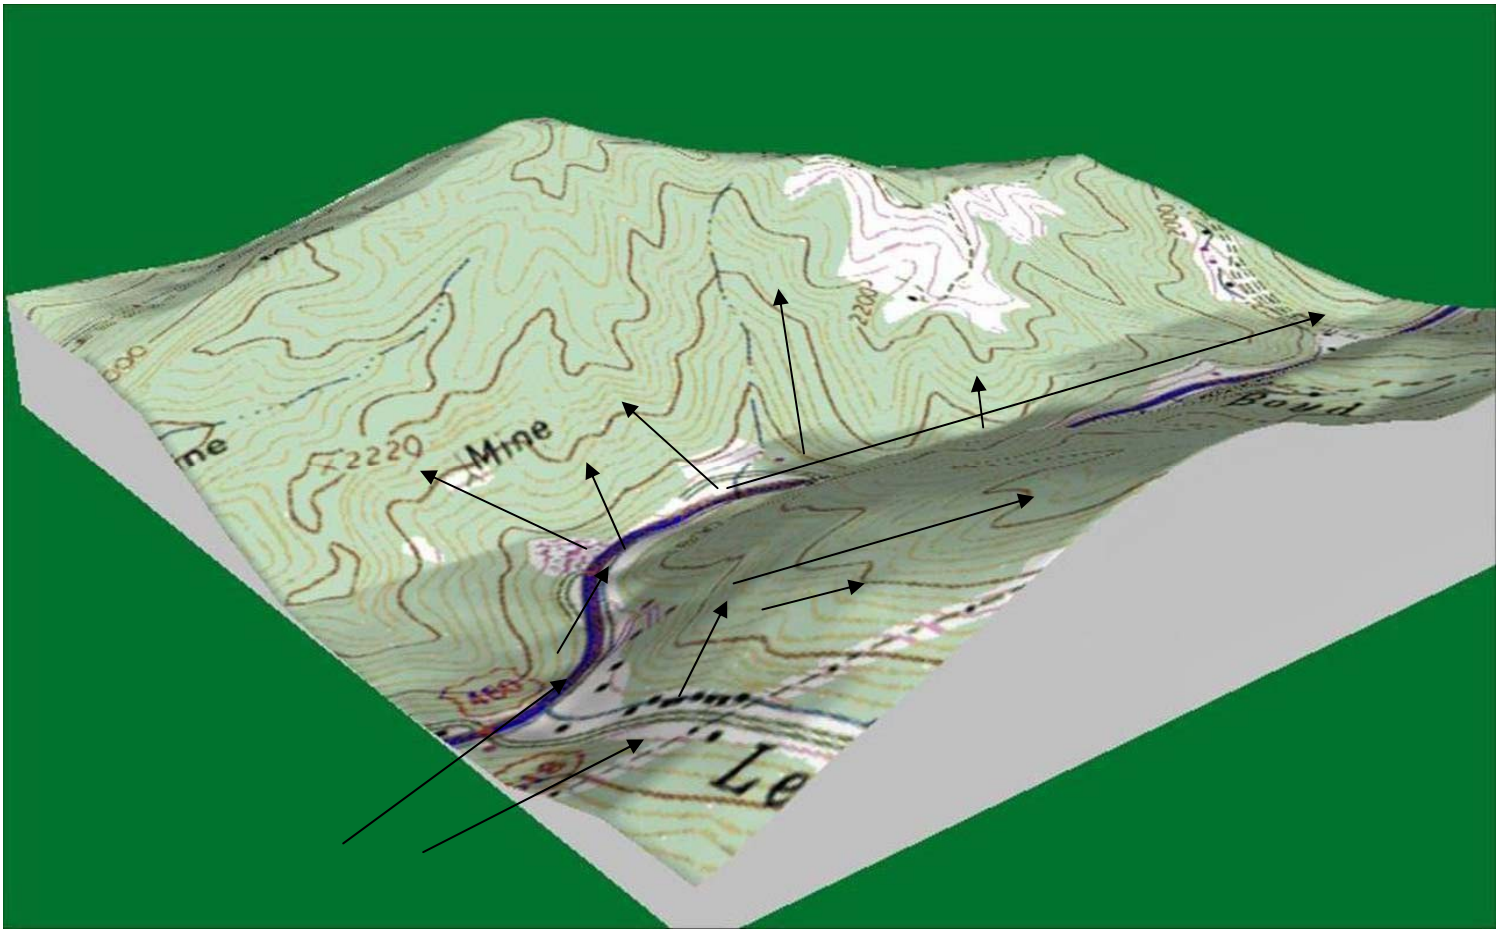
Figure 4

Effects of Up-valley and Up-slope Winds

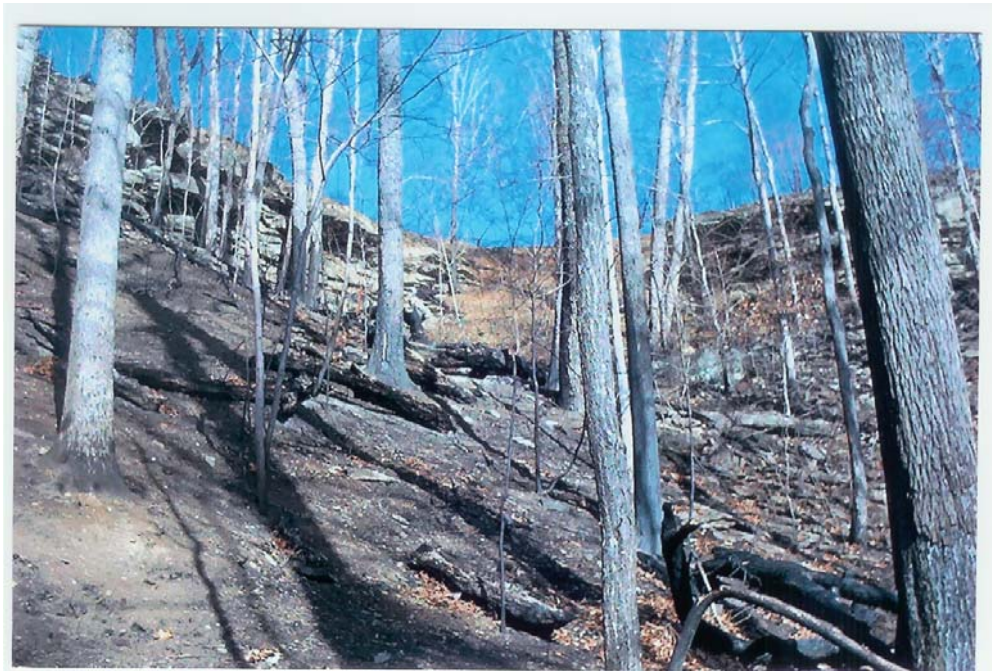
Figure 5

The topography at the Marvin Fire is characterized by the predominance of steep terrain. At the ignition point of the fire, and in the area where the fatality occurred, slopes were 47-50%, steep, and rocky. The base elevation change from the ignition point of the fire to the top of the ridge just above where the victim was found was 600 vertical feet; with a horizontal distance of 1200 feet. In the area located just above residence #2 (figure 6), the terrain was slightly less steep and averaged 33%. As can be seen in figure 4 above, the terrain was cut by numerous steep canyons or "hollows". These natural chimneys provided a natural avenue for wind to travel upslope at faster rates than if the terrain were flat. Fire naturally channels into these areas and travels rapidly uphill assisted by the wind. In addition, the ridge top located immediately above the victim was configured as a

saddle, that is, a middle area of low ground surrounded by higher ground on either side (figure 5). Saddles channel wind (and fire) through the center of this type of terrain largely due to the compression and “funneling” effect of wind between the higher ground on either side of the low point. The history of wildland fire fighting fatalities involving this particular type of terrain feature is significant. Many fatalities have been shown to have been the result of situations where steep canyons and saddles served as precipitating factors in creating conditions where extreme fire behavior was the end result.

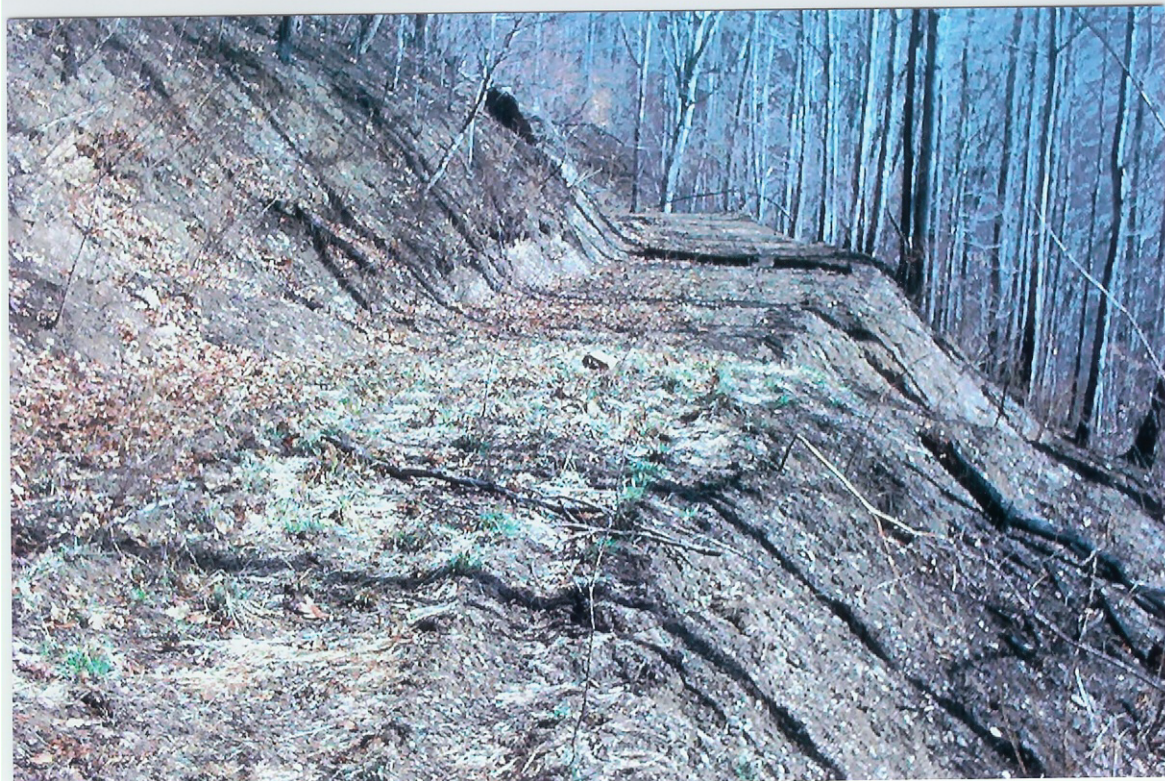
Figure 7

The presence of several old logging grades (see figure 7) in the assessment area were responsible for two changes in forward spread of the fire. First, they tended to act as a barrier to fire movement, slowing down the forward rate of spread of the fire, largely by providing an area of flat ground and more sparse fuels. Secondly, they caused the head of the fire to move laterally until such time as either spotting occurred across the grade or the fire was able to traverse the grade laterally to an area where it was narrow enough to move into receptive fuels on the slopes above. Once the fire crossed across the barrier(s) provided by the logging grades, it again commenced making rapid uphill runs with characteristic increased fire spread towards the summit of the assessment area. These logging grades are not shown on any of the maps of the assessment area, though it is thought that Chief Willard would have known of their existence.

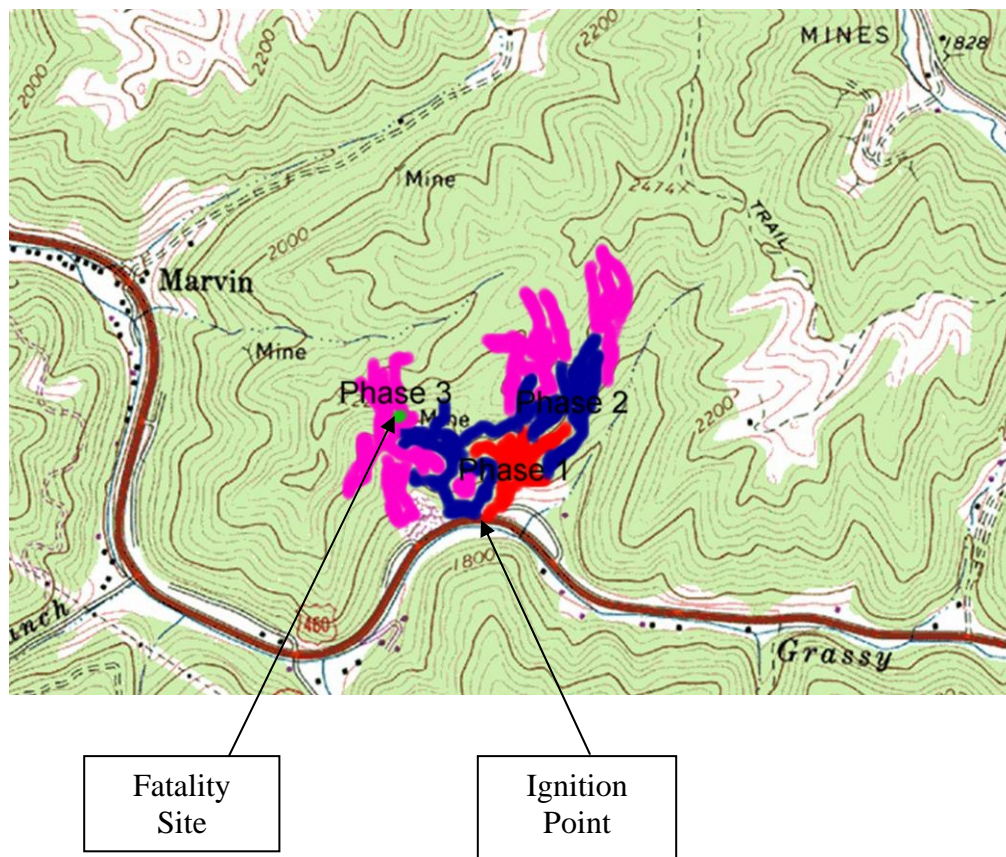
Figure 8

Conditions for very active wildland fire behavior were in place by 1100-1200 on November 12, 2005 at the location of the Marvin Fire in Buchanan County, Virginia. The area was in extended drought (KBDI 502, Keetch-Byram Drought Index, Palmer Drought Index); fine fuels were in abundance on the ground and were very dry (fine fuel moistures between 2%-4%) and “fluffy” having just fallen from the deciduous trees that dominate the assessment area; temperatures (mid 60’s) were unseasonably warm for the time of the year (November); relative humidity was *very* low (2-19%; 15% average); winds in the assessment area, though not considered extreme in their intensity, were considerable when combined with low relative humidity, steep terrain at the assessment site, the synergistic effect of mid-day upslope winds, up valley winds, the presence of steep canyons, chimney’s, saddles, a south-southeast aspect; southerly wind direction upslope, etc. Forward rates of spread (ROS) from the point of ignition were between 11 and 52 chains (1 chain = 66 ft) per hour, with 21 chains per hour being the probable average ROS. Average flame lengths were between 3.4 and 7.6 feet. These figures *may be understated* since fire behavior models generally do *not* accurately predict rates of spread caused by the spotting that results from blowing leaves (ground spotting). Lower flame lengths were probably only in evidence at the lower elevations during the first few minutes of the fire. Within a short period of time, the fire started to travel upslope at increased rates of spread, primarily due to the effects of terrain slope and upslope winds and their effects on the head of the fire. Phase 1 on figure 8 depicts the fire spread from the point of ignition based upon the fuel, weather, and topography factors already discussed in this assessment. Note that in Phase 1 the fire moved uphill at approximately 220 degrees (measured clockwise from uphill) at rapid rates of spread noted above. At this point the fire was *not* moving directly uphill towards the area where the fatality occurred. Instead, it was traveling directly uphill from the ignition point into an area of very steep terrain. However, at the same time, the flank of the fire was beginning to move laterally to the west and was slowly working its way towards steeper terrain and more abundant fine fuels before beginning its uphill run. (Phase 2). As was discussed earlier, it is likely that the presence of old logging grades in the area may have retarded the uphill advance of the fire to the west. The elapsed time for phase 1 was likely between 45 minutes to 1 hour. Phase 2 spread began at 45-60 minutes> and continued until 1 to 1 ½ hours had elapsed. At that point Phase 3 began, where side-hill fire movement on the west flank (almost directly below where the victim was ultimately found) was quickly beginning to convert into strong and rapid uphill runs at rates of spread (ROS) likely exceeding 29 chains per hour. Smoke production was likely very heavy during this phase of the fire and may have been a contributing factor in the fatality. The entire ridgeline located above the fatality site would have been completely engulfed in heavy smoke with visibility and oxygen availability being reduced to an absolute minimum level.

The head of the fire reached the fatality site between 2 -2 ½ hours (likely at approximately 1330-1400) after the initial ignition of the fire along Highway 460. It is important to note that the effects of heavy smoke and heat from the head of the fire would have had a significant impact on the area where the fatality occurred, perhaps as much as 15-20 minutes prior to the arrival of the head of the fire. Once the fire funneled through the saddle located just above the fatality site, it moved into areas where heavier fuels and brush were present on the ridge top. In addition, the fire continued to move laterally on both flanks until it was able to acquire favorable terrain and fuels, resulting in strong uphill runs towards the ridge tops all along the spreading flanks of the fire.

- At the completion of Phase 1 the fire was approximately 10-20 acres in size.
- At the completion of Phase 2 the fire was approximately 41 acres in size
- At the completion of Phase 3 the fire was approximately 92+ acres in size.
